Manhole Inspection Summary

Manhole # S01UU1024MH

Insp Date: **7/31/06 7:43 AM**

Location Address: **3808 Menlo Dr**

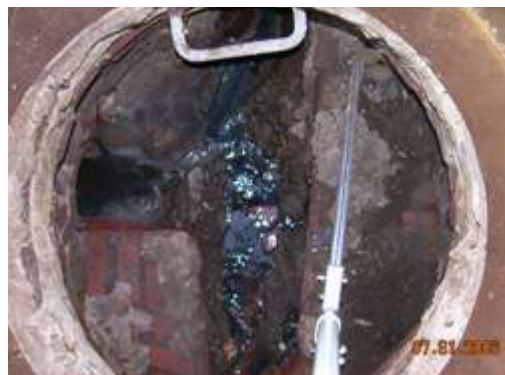
Top View

Condition: ☐ Sound ☒ **Cracked** ☐ Root Intrusion ☐ Loose Brick ☐ Deteriorated

Condition: ☐ Sound ☐ Cracked ☐ Root Intrusion ☐ Deteriorated ☐ Leaks ☒ **Debris**

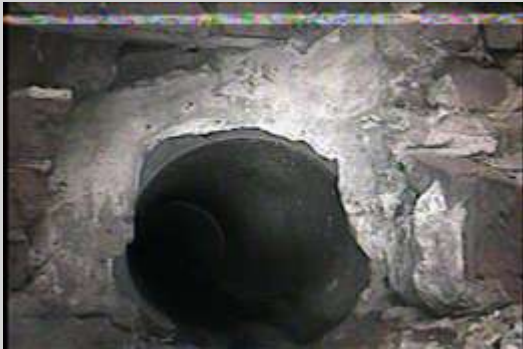
8 in. Circular Gravity Sewer Pipe Out @ 12 O'Clock

Invert Depth: **4.07** (ft.) Flow Characteristics: **Slow**

Deposits: ☒ None ☐ Mud ☐ Sludge ☐ **Debris** ☐ Grease

Infiltration: **None** Pipe Seal Cond: **Sound**

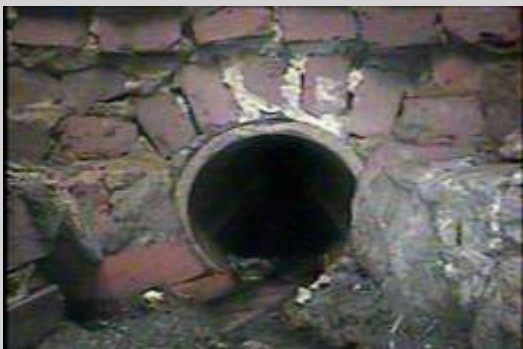
8 in. Circular Gravity Sewer Pipe In @ 6 O'Clock

Invert Depth: **3.78** (ft.) Flow Characteristics: **Slow**

Deposits: ☐ None ☐ Mud ☐ Sludge ☒ **Debris** ☐ Grease

Silt Depth: **0.125** (in.) Deposits Extent: **Light**

Infiltration: **None** Pipe Seal Cond: **Sound**

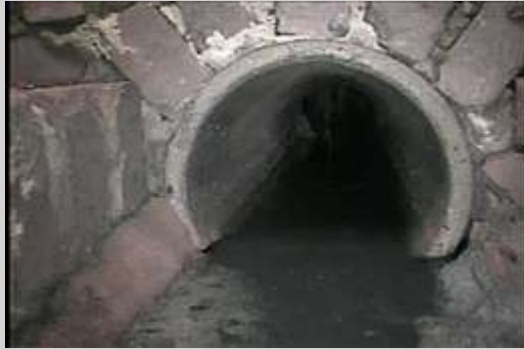
8 in. Circular Gravity Sewer

Invert Depth: **3.80** (ft.) Flow Characteristics: **Slow**

Deposits: ☐ None ☐ Mud ☐ Sludge ☒ **Debris** ☐ Grease

Silt Depth: **0.125** (in.)

Deposits Extent: **Light**

Infiltration: **None**
